**3R2N Terrestrial Report: Allegheny River
Phase 3 - 2002
Riverbank Geology**

**Roman G. Kyshakevych, Ph.D.
Henry Prellwitz, Ph.D.
3 Rivers 2nd Nature
STUDIO for Creative Inquiry
Carnegie Mellon University**

Riverbank Geology

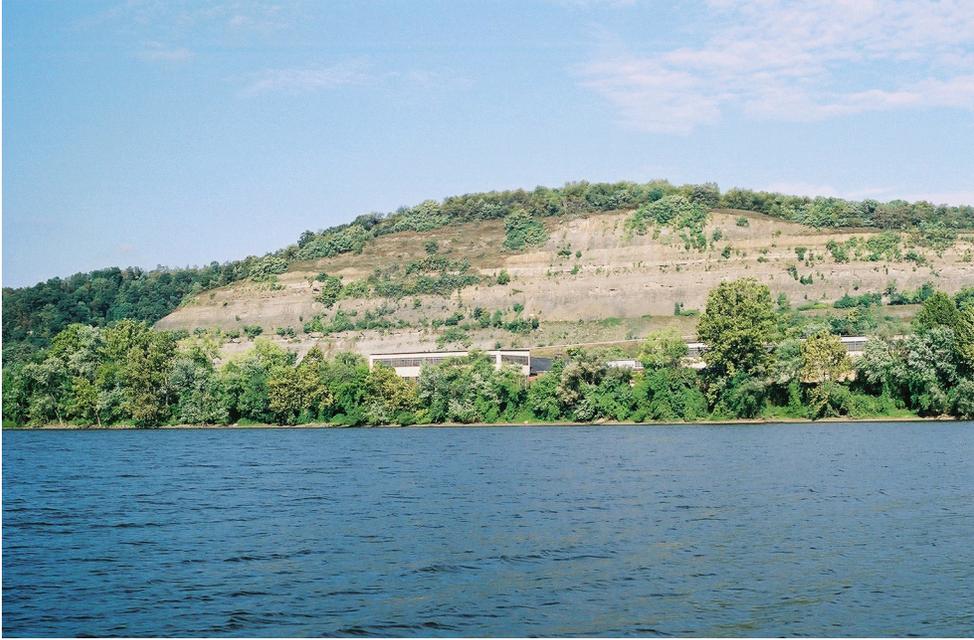
Fig. 3. Bedrock layers as currently seen from the Allegheny River

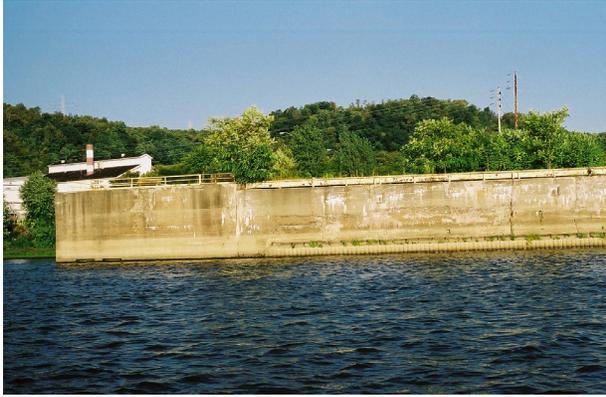
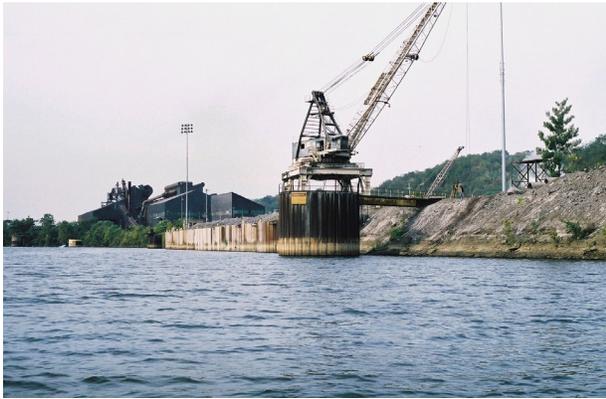
Figures 10, 11, and 12 show riverbanks that are vertical, and have consolidated materials that are manmade. These banks are classified under the “no access” category. Figure 10 is a high cement dock, now inactive, that was once used by PPG Industries, near Glassmere, PA. This wall is over twenty-five feet high. Figure 11 is a steel bulkhead used as a dock for Allegheny Ludlum Steel Co. in Natrona, PA. These walls are over twenty feet high. The third photograph (fig. 12) is an example of a vertical high wall built from large interlocking cement blocks, used as a barge loading dock. Many industrial sites along the Allegheny River utilized an unsaleable waste product as a building aggregate, increasing the amount of level land above high flood stage.

Fig. 10. Vertical riverbank, consolidated manmade materials

Fig. 11. Vertical riverbank, consolidated manmade materials

Fig. 12. Vertical riverbank, consolidated manmade materials

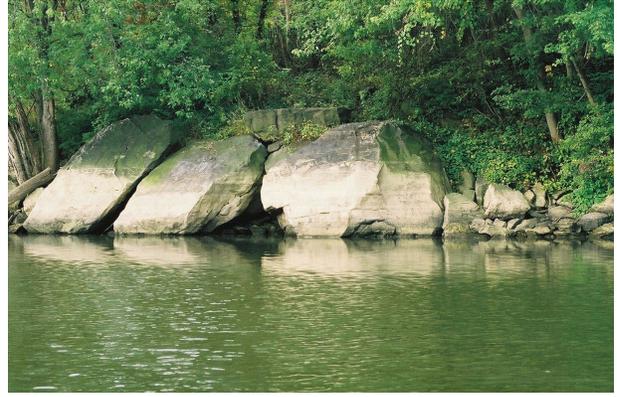
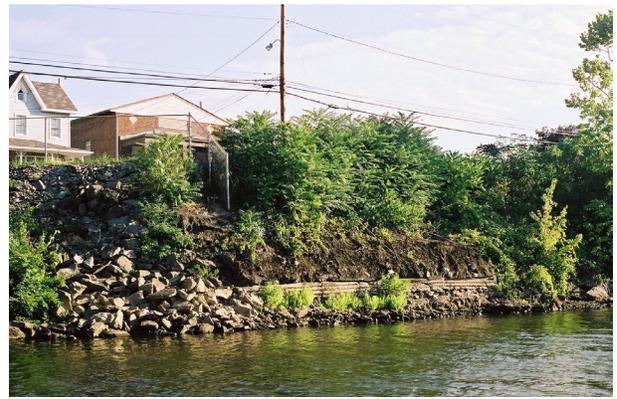
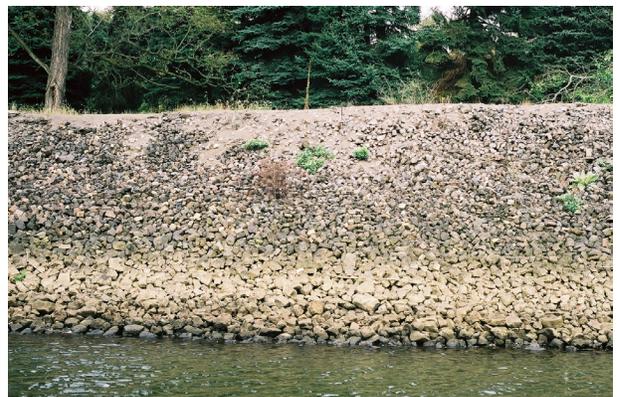
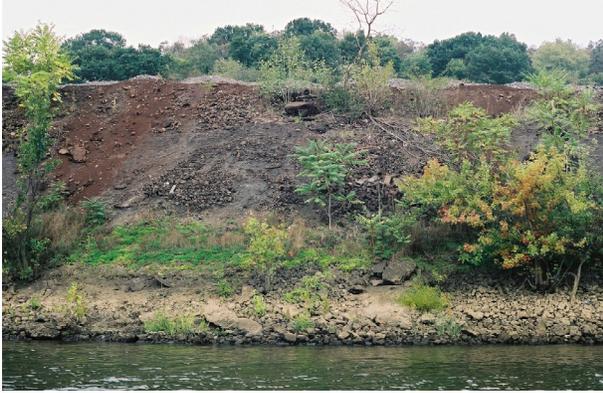
Figures 13, 14, 15, and 16 are areas that have difficult, but possible access. There is a lack of berm in these examples, the grain sizes of the bank materials are very coarse (boulder sizes), and the bank slope is steep, prohibiting easy landing from the water. Figure 13 is a portion of bank where large boulders of natural bedrock have slid down the bank, and lie at the water’s edge making access very difficult. Figure 14 depicts a similar situation as in figure 13, but the boulders were placed by man, as a bank stabilization tool. Figure 15 is a portion of the left bank of the Allegheny River just below Lock and Dam #4, at Natrona, Pa.; the bank has been stabilized with boulder to cobble sized stones, set in an orderly fashion. The dam highwalls upriver are vertical, or “no access” areas. Figure 16 is a steep bank built up using industrial waste, including slag and coal mine refuse. The bank is steep, there is no berm, and boat landing is difficult here, classifying this as a “moderate” to “difficult” access area.

Fig. 13. Natural bedrock

Fig. 14. Edge access difficult

Fig. 15. Stabilized bank

Fig. 16. Moderate to difficult access

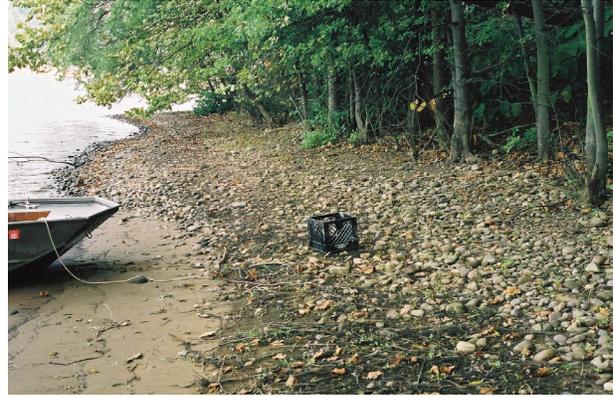
Figure 19 is a shallow angled berm, with a large sand percentage. This bimodal grain size distribution is common along the Allegheny River, with berm areas that consist of cobbles and sand only. The cobbles here are very well rounded, and appear to have been transported a long distance. This berm is composed of over 50% exotic (natural) cobbles, with over 30% of the cobbles igneous and metamorphic rocks. Access is clearly easy here, as the berm slope is slight, and the shore is sandy, permitting easy small boat landing.

Fig. 19. Coarse material, shallow angled berm

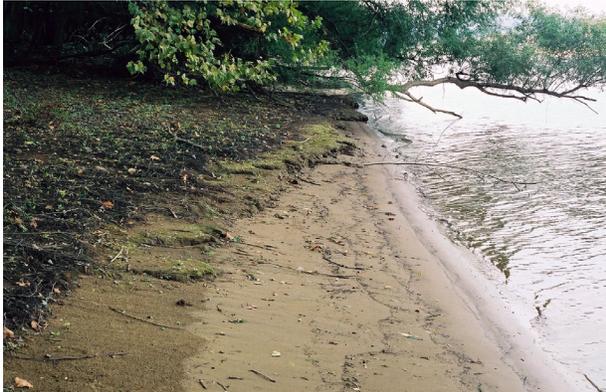
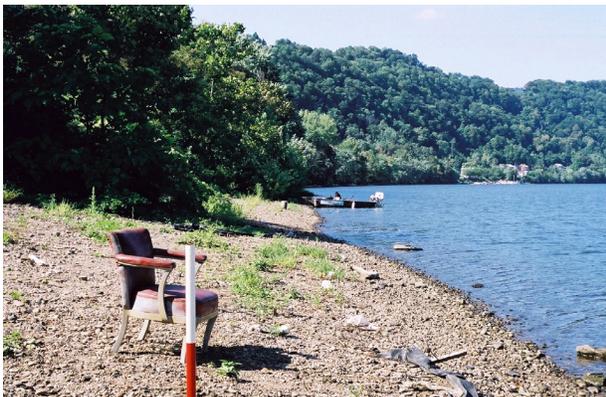
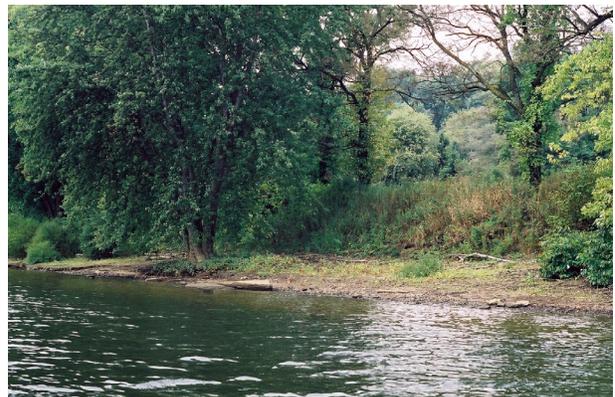
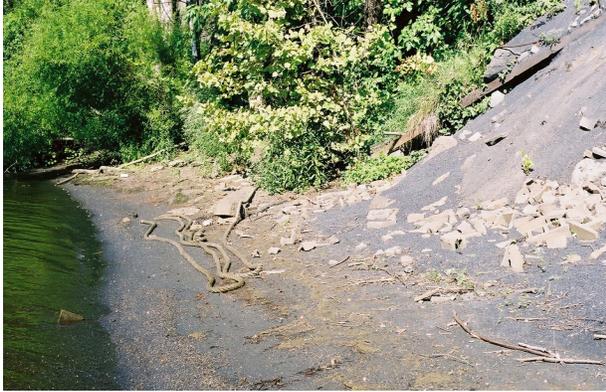
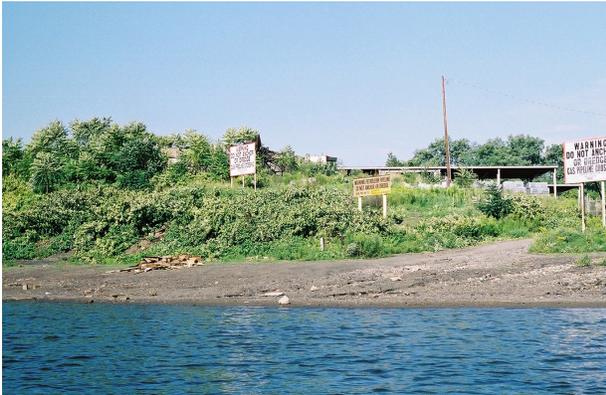
Figures 17, 18, 19, 20, 21, 22, and 23 all show bank and berm conditions along the Allegheny River that have “easy” access conditions. Figure 17 is a photograph of a wide berm, with a slight low bank in the background. This is “easy” access, but not ideal access, as the berm has a high concentration of silt and mud, making a boat landing slightly unpleasant, due to soft conditions. Figure 18 has ideal accessibility; the berm slope is slight, and the materials consist of sand and coarse sand, making boat landing easy and pleasant. The low bank (about twelve feet high) is also very sandy, and this is a typical low floodplain deposit, usually seen on the inside of river bends. This is also known as a “point bar” deposit. The berm shown in figure 19 is of coarser material than in the previous two photographs; most of the material is pebble size, with about 20% of the berm as cobble size grains. This berm has easy access, as landing here was not difficult or unpleasant, due to lack of soft mud and silt. Figures 20 and 21 also show easy access, which are both in more natural settings; in both cases, the bank heights are low, and the berm is wide with a slight slope. Figures 22 and 23 are examples of easy

access, but these areas are less aesthetically pleasing, as the berm and bank materials consist of industrial waste products. The ease of landing a small boat at these sites is not hampered, however.

Fig. 17. Wide berm

Fig. 18. Ideal accessibility

Fig. 21. Easy access, natural setting

Fig. 22. Easy acces, non-aesthetically pleasing

Fig. 23. Easy access, non-aesthetically pleasing

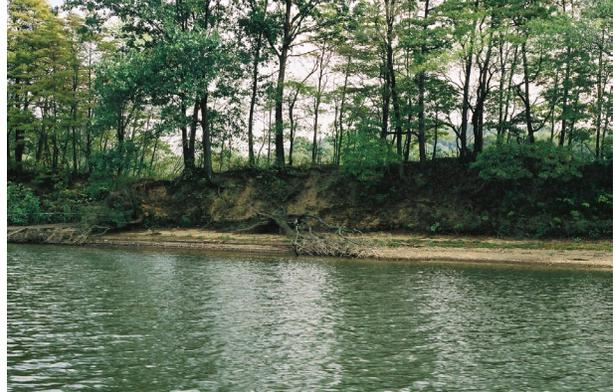
Figure 20 shows a sandy berm (with a small

amount of mud) along with a bank that is mostly mud. This is a good example of a low floodplain that is about ten feet high above water level, and is probably underwater once every five years. The berm is mostly sand, with some pebble sized grains, mixed with mud. Access is good here, as boat landing is easy. Figure 17 is a berm that is about 50% sand and 50% mud; access is also easy here, if one steps from their boat onto the sandy areas, and avoids the mud. In this specific locality, mud has been deposited on top of the sand layer, from a flooding event. Figure 33 is a berm that is 100% mud; access is unpleasant here, as one will sink quickly in the mud when stepping from a boat.

Fig. 20. Easy access, natural setting, sandy berm

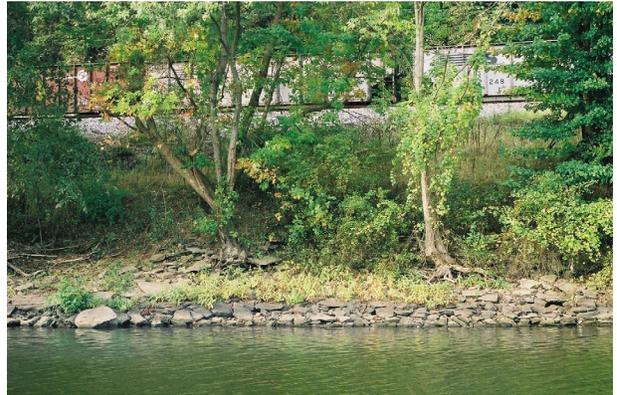
Fig. 26. Mix of man-made materials

Man-made bank and berm conditions were observed during the 2002 field season on the Allegheny River. Unconsolidated man-made bank and berm materials include steel mill slag, coal mine refuse piles, cement plant waste material, boulders dumped along the bank to stabilize erosion, and material dumped as fill for railroad and highway rights-of-way. Consolidated man-made materials include cement docks and bulkheads, stone and brick walls, structures at water level (fig. 24), steel and wood retaining walls, dumped cement, and solidified slag. Other man-made materials that do not fall into the above categories include odd trash dumped along the riverbank, and occasional wrecks (fig. 25). Examples of consolidated man-made bank materials are cement walls, steel piling walls, and cement block walls (fig. 10, 11, and 12). Figure 26 shows a mixture of man-made materials: the railroad line is built on introduced fill, including slag and natural material. The berm, along the water's edge, has been covered with introduced boulder sized natural material (sandstone) to control erosion.

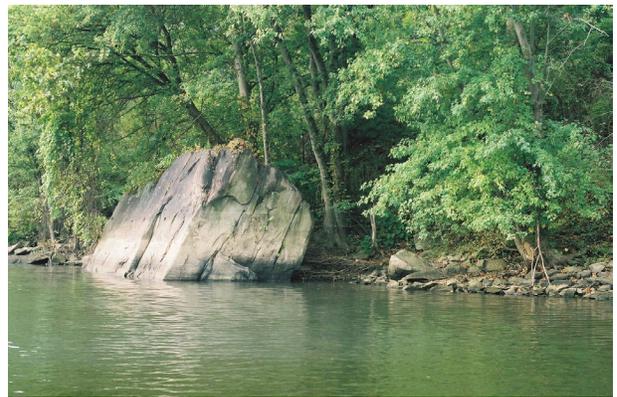
amount of coal. The local bedrock in the Allegheny River basin is similar to that of the Monongahela River watershed, except for a lesser amount of coal. Figure 27 shows large natural boulders of local sandstone that have slid down to the water's edge.

Fig. 27. Large boulder

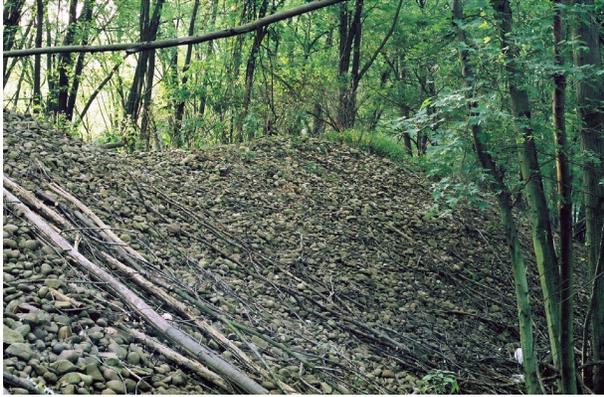
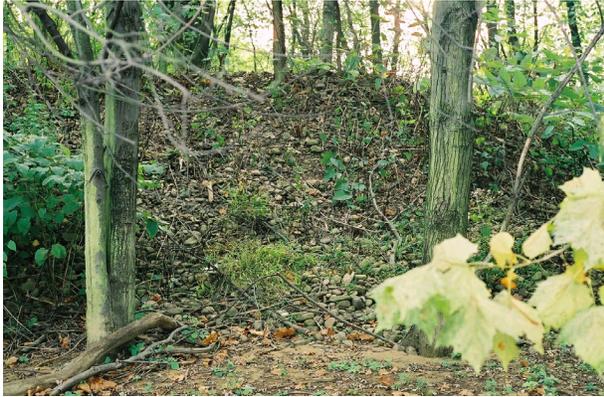
Figures 28 and 29 are photographs of a large gravel bank on the north side of Jack's Island. This bank is about 10 feet high, and consists mostly of cobble sized material, with a lesser amount of pebble and sand sized grains. Much of this material has been introduced to the area, from transport by glacial ice. Much of the exotic material is from the Canadian Shield, which is made up of pre-Cambrian rock, ranging in age from 1.2 to 2.6 billion years old. A one meter square was imposed on a flat portion of this gravel bank, and a cobble count performed; the results are as follows:

Local sedimentary material (sandstone, shale, etc.)	67%
Exotic sedimentary material (sandstone, limestone, etc.)	14%
Exotic metamorphic material (gneiss, quartzite, etc.)	17%
Exotic igneous material (granite, gabbro, etc.)	2%

The exotic sedimentary cobbles were identified by fossil content and species; this percentage could be higher, if ambiguities in field identification were eliminated. Most fossils collected from introduced sedimentary rocks were of Silurian age (fig. 1, Geological Time Scale) and these rocks are exposed on the surface in the Buffalo, New York area, but deeply buried in the Pittsburgh region. Since there are no surface exposures of metamorphic or igneous rocks within the Allegheny River drainage basin, these cobbles are definitely of exotic origin, even though they were transported and deposited by natural processes. Metamorphic rocks occur about 16,000 feet down in the Pittsburgh area.

Fig. 28. Large gravel bank

Fig. 29. Large gravel bank

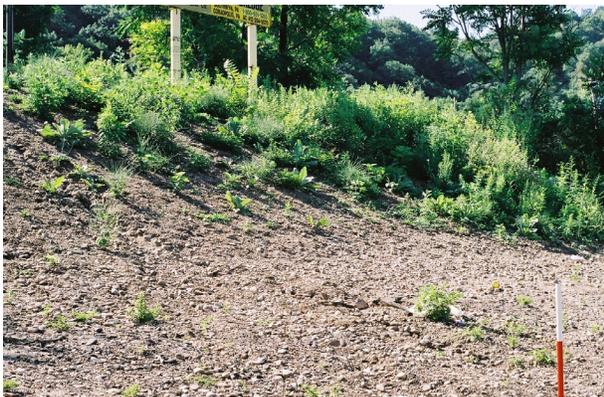
Figures 30 and 31 show a berm and bank, respectively, that have a slightly finer grain size distribution than at Jack's Island. Most of the gravel here is pebble size, with some larger cobbles included, and a greater amount of sand. The berm has a shallow slope (allowing good access) and the bank is not too steep to easily walk up, allowing fine access to the road above. The materials here are mostly of local origin; about 15% of the pebbles and cobbles are exotic. A few fragments of man-made introduced material can be seen in figure 30, in the form of coal, bricks, and cement blocks. The natural grains (pebble and cobble sizes) are well rounded, implying a certain amount of transportation (by water and ice) from the original source. By contrast, most larger sized grains in the Monongahela River are more angular in shape, inferring shorter movement distance from their source.

Fig. 31. Introduced material, bank

Fig. 30. Introduced material, berm

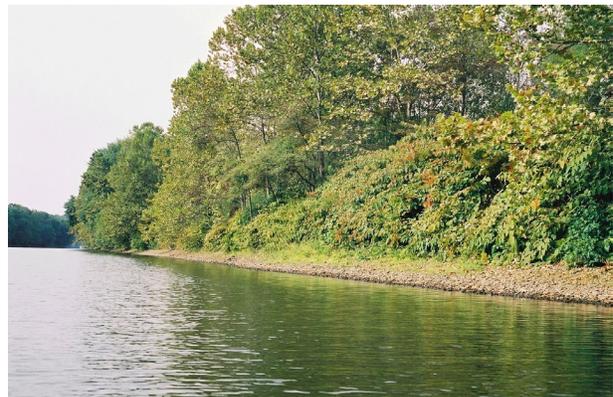
A berm that grades downstream from cobble to pebble to sand sized grains is shown in figure 32. This berm is on the southeast bank of Jack's Island, just above Lock and Dam #4. The photo is facing downstream, with the dam top on the horizon. As the grain size fines downstream, the angle of repose changes; the cobbles can support a steeper angle, and the sandier berm a lesser slope. Access is easy on the downstream portion of the island, and is a little more difficult upstream; many islands in the Allegheny River are coarser grained on the upstream end, and fine downstream. The lithological makeup of the cobbles and pebbles is similar to that in figures 28 and 29.

Fig. 32. Berm gradation

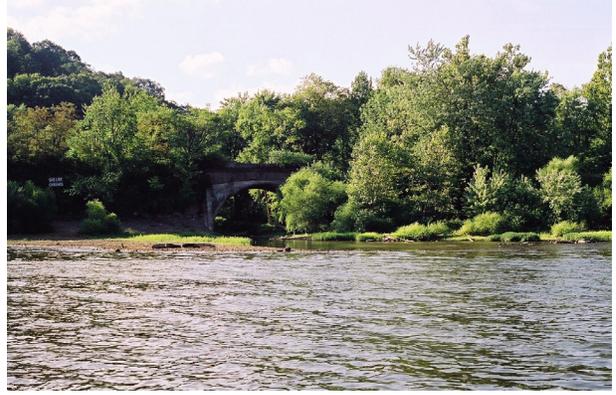
A small stream delta into the Allegheny River is shown in figure 34. This particular stream is Chartier's Run, on the southeast bank of the Allegheny, in Pool 4. The Allegheny is flowing from left to right in this photo. In this case, the coarser material is on the upstream side of the delta, and the finer material is downstream. This is due to the slowing action of the delta deposits during flooding events, where finer grained material drops out of a moving river when slowed. The initial impact of moving floodwater on the delta (just before it slows down) is to remove fine grained sediments on the upstream side. This is also true for many of the Allegheny River islands, where the upstream end is being eroded, and the downstream end is a site for sediment deposition. The islands very slowly migrate downstream from these erosion and deposition processes.

Fig. 34. Small stream delta
